# DOOR SURVEY

## Regency Square

**35/36 Regency Square, Brighton, East Sussex,  
BN1 2FJ**

ASSESSMENT REF. RB-28DNM6

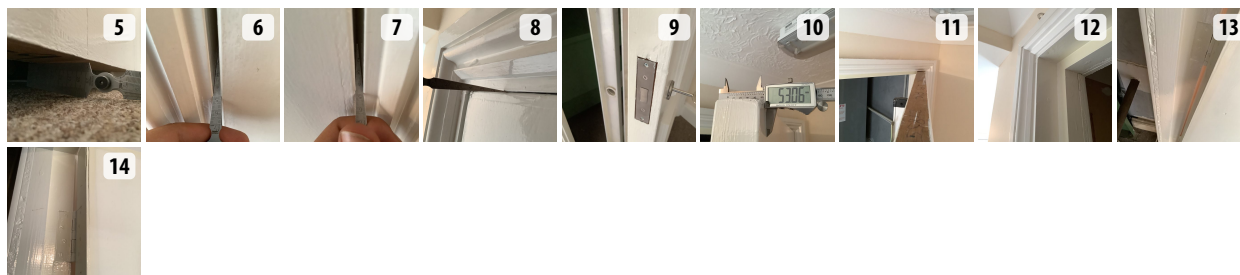
## Lift motor room door

Adjust door gaps. Replace with intumescent lock

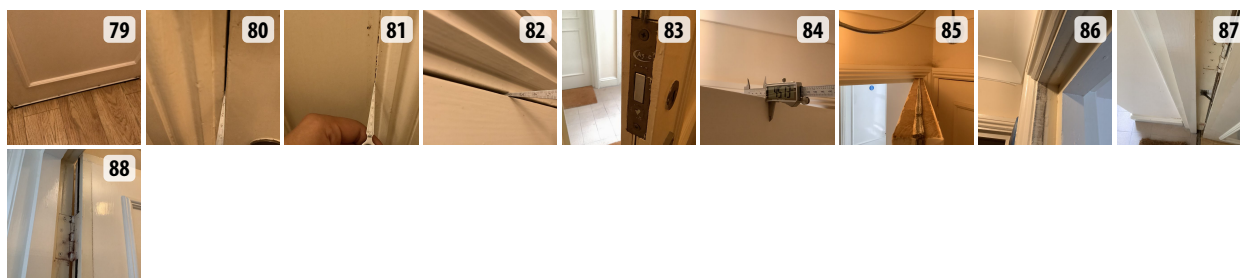
Adjust door gaps. Replace hinges with 3nr fire-rated hinges

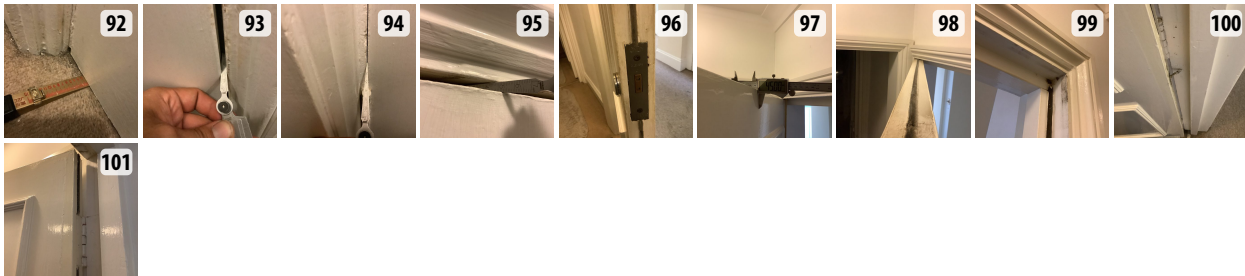
Adjust door gaps. Replace hinges with 3nr fire-rated hinges. Replace self-closer. Replace with intumescent lock

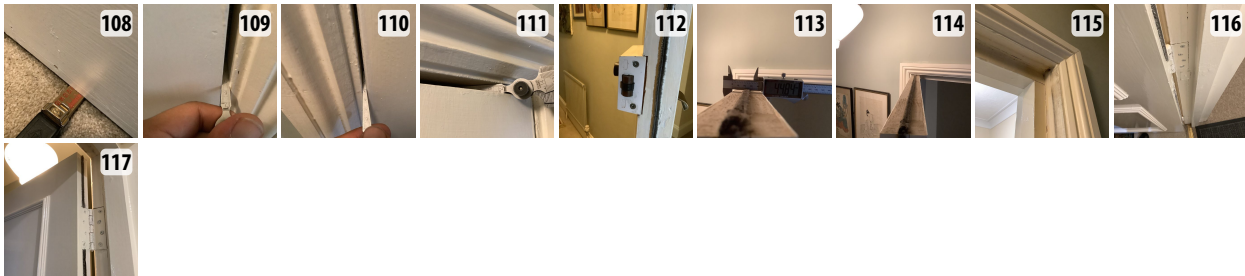
## Flat 10

Adjust door gaps. Replace hinges with 3nr fire-rated hinges. Replace self-closer. Replace with intumescent lock

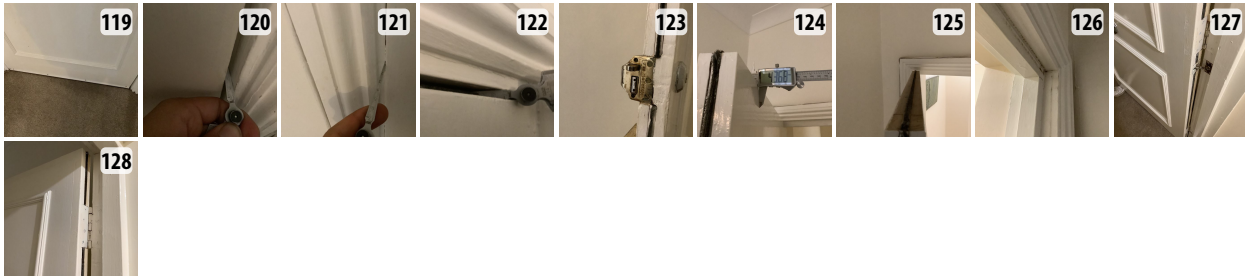
Adjust door gaps. Replace hinges with 3nr fire-rated hinges. Replace with FD30s doorset. Replace with intumescent lock. Door touches carpet when closing

Door needs to be replaced with FD30 door set as it's below 44mm

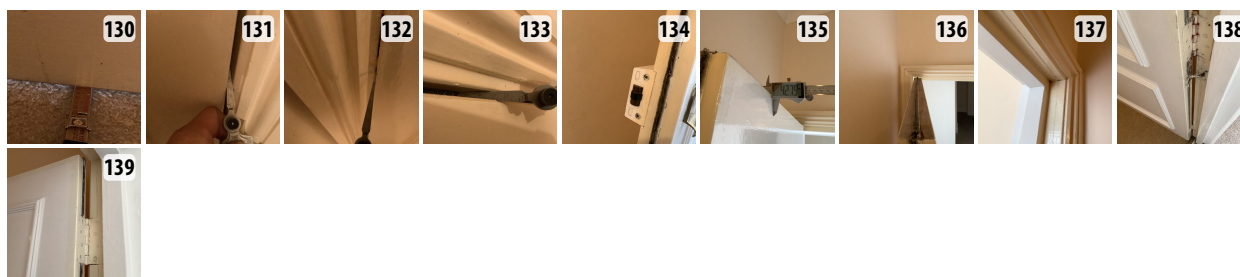
Adjust door gaps. Replace hinges with 3nr fire-rated hinges. Replace self-closer. Replace with FD30s doorset. Replace with intumescent lock

Door needs to be replaced with FD30 door set as it's below 44mm

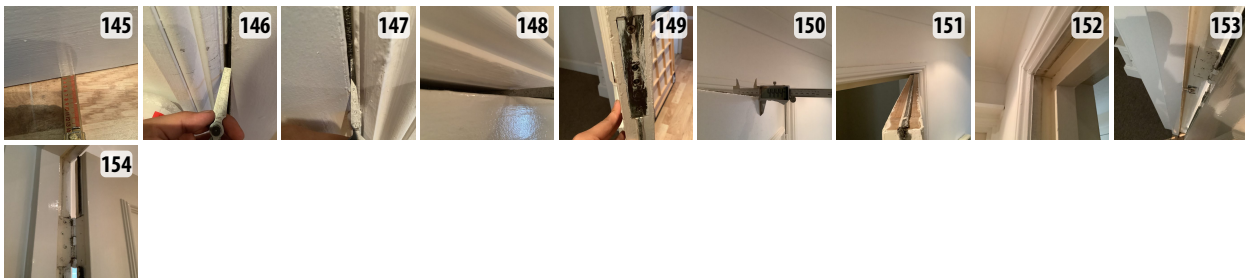
Adjust door gaps. Renew hinge screws. Replace hinges with 3nr fire-rated hinges. Replace self-closer
